1993 Toyota Townace Wagon 4-door  
Royal Lounge Limited Edition

Car Detail

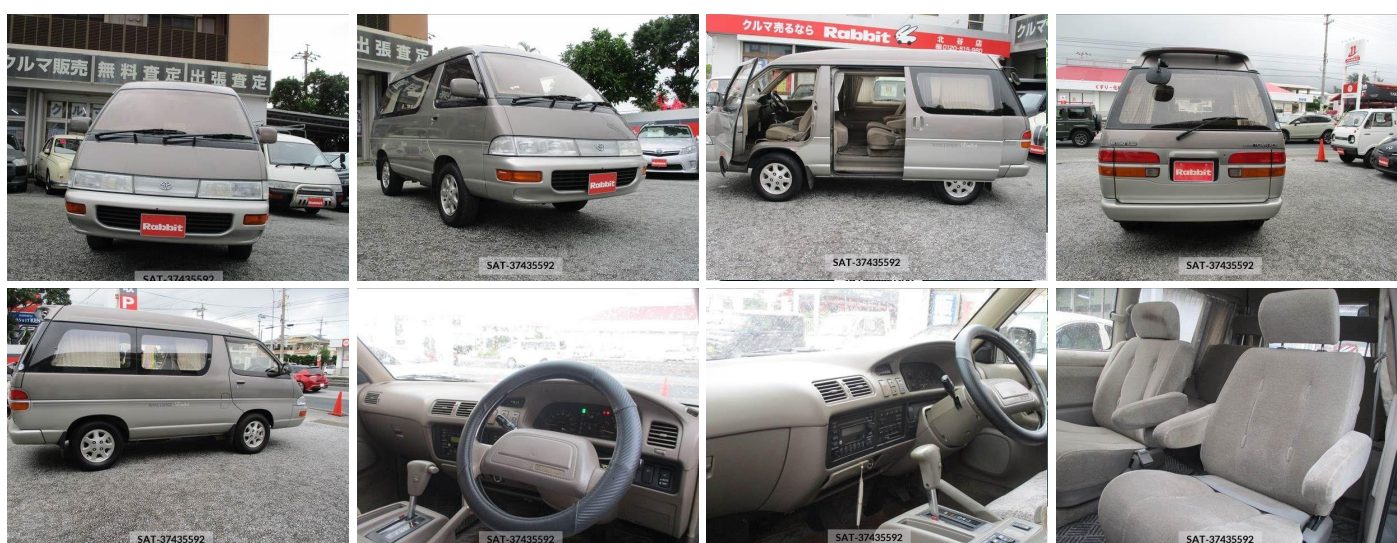
Vehicle Pictures

Parameter	Comment	Points
Pillar Right C	The right C-pillar shows some wear, including minor dents or scratches, but remains structurally sound.	3
Running Border Left	The left running board shows some signs of wear, including scratches or minor dents, but remains functional.	3
Running Border Right	The right running board is in excellent condition, showing no signs of wear or damage.	5
Left Quarter Pane	The left quarter panel is in good condition with only minor cosmetic imperfections.	4
Right Quarter Pane	The right quarter panel shows some visible signs of wear. Some cosmetic repairs are recommended.	3
